CARR - 731

1443 OLD MANCHESTER ROAD

mid-19th century

Westminster vicinity

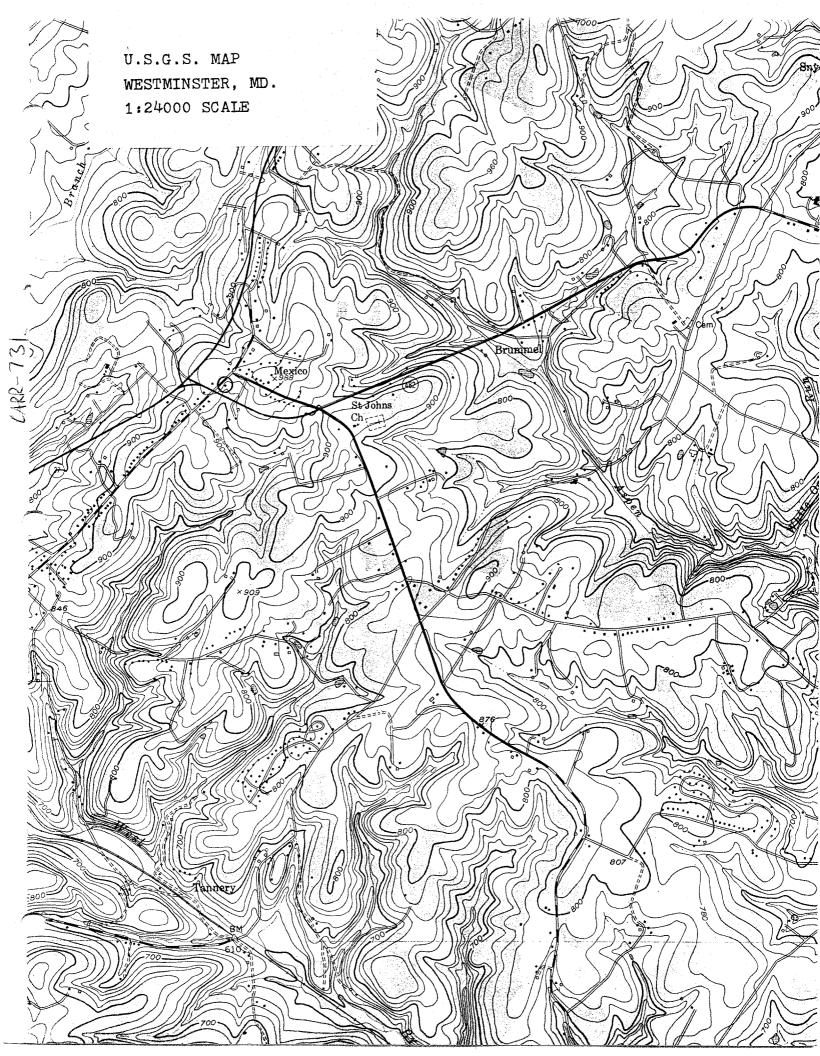
- 1. CARR-731 1443 OLD MANCHESTER ROAD
- 2. Carroll County, Maryland
- 3. Joe Getty
- 4. August 1983
- 5. Md. Historical Trust, Annapolis, Md.
- 6. North and west elevations (camera facing southeast)
- 7. 1/1
